### **SUMMARY ENGINEERING REPORT**

**HOMEOWNER:** Don Bell

**ADDRESS:** 9030 County Road 59 Pineapple, AL.

**DATE OF LOSS:** 9/16/04, HURRICANE IVAN

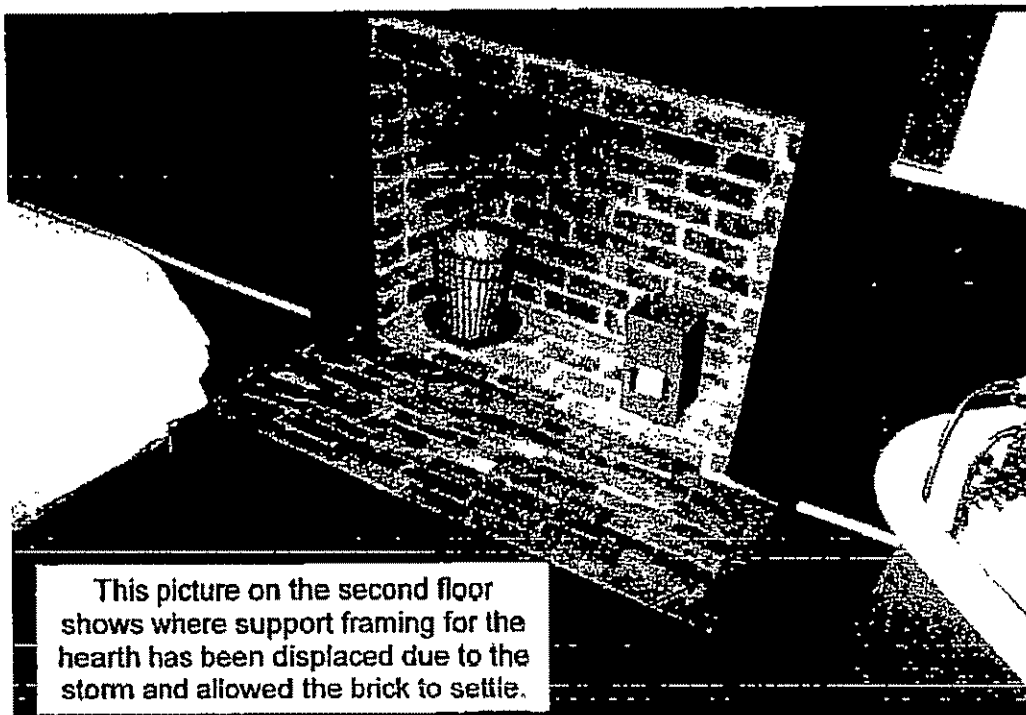
The picture above shows some warping of the floor boards on the first floor. Notice the lifting of the board along the wall at the left. The main support beam of

the north main bearing wall has suffered significant termite damage. The termites do not appear to be active at this time.

The two main rooms downstairs appear to slope to the north and west. The floors are sloping and the wall has settled due to termite weakened floor beams being "crushed" during the high wind loads from Hurricane Ivan. The repair for these weakened members is replacing the members or reinforcing the member with new material. The locations of these damaged members are shown on the attached floor plan.
